Experiences with RMC during the Implementation of the Mt. Coffee Emergency Spillway

A. Wetzel, Dr. A. Trifkovic
Fichtner GmbH & Co. KG
P.O. Box 101454
70013 Stuttgart
Germany

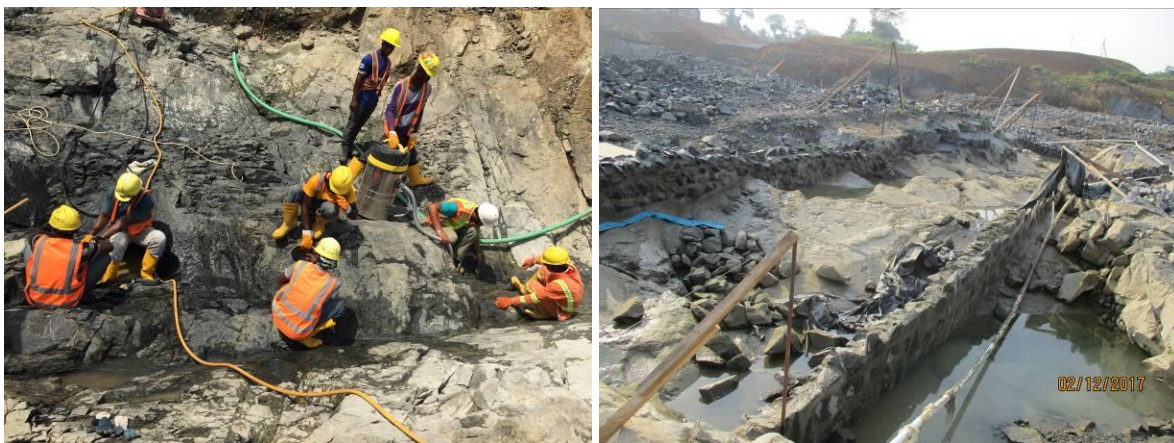
Figure 4 - Left: Foundation preparation using industrial type vacuum cleaners, Right: Walling off the section to be poured with mortar layer

The foundation is mainly characterized by Gneiss, a dominant Dolerite Dyke and other Mafic Intrusions which are competent foundation material for the ES weir with a rock rating into class II and III according to the RMR system by Bieniawski. The rock foundation was cleaned and washed numerous times using industrial type vacuum cleaners, blowers or compressors, chipping hammers, buckets, sponges and clean water to assure that loose particles, dust or water was removed prior to the placement of RMC.

As can be seen, firstly the outside walls were constructed using a 'sticky mortar' in lifts of approximately 500 mm. Once a section has been walled off, the ingress of water was prevented from surrounding ponds and filling between the walls with RMC in the matrix could be done.

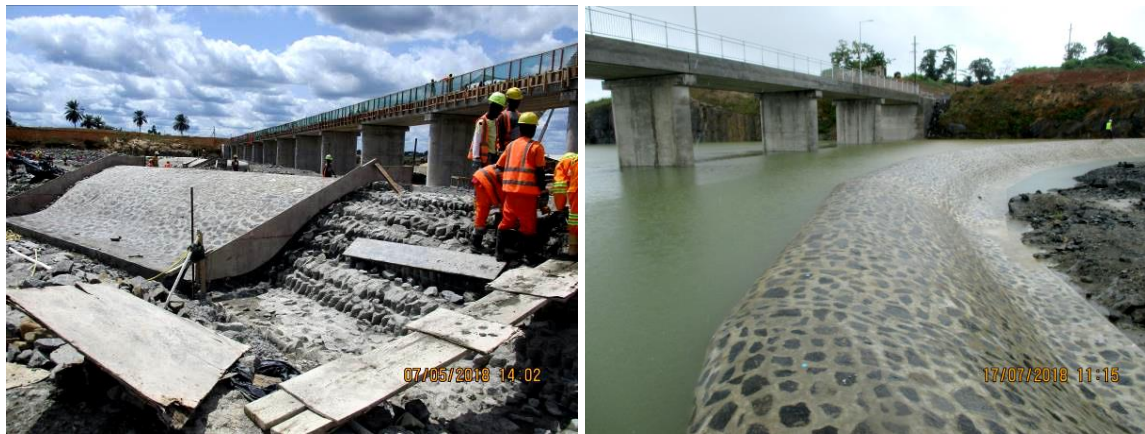
Figure 5 - Left: Use of shutter ply profiles and fish line for Final Shape, Right: Smooth finish of ogee spillway shape

For the final ogee spillway shape two wooden profiles spaced between 5m and 8m with fish line strung across at 100 mm c/c were erected to guide the placing and shape of the spillway crest. The final shape was built in sections of 5-8 m widths. Care was taken in the selection and placement of the final layer of stones so that as smooth as possible final surface without irregularities was obtained. Once the final shape was constructed and set, blankets were placed over the structure and constantly cured by wetting with hose pipes and buckets of water until the final strength was achieved.

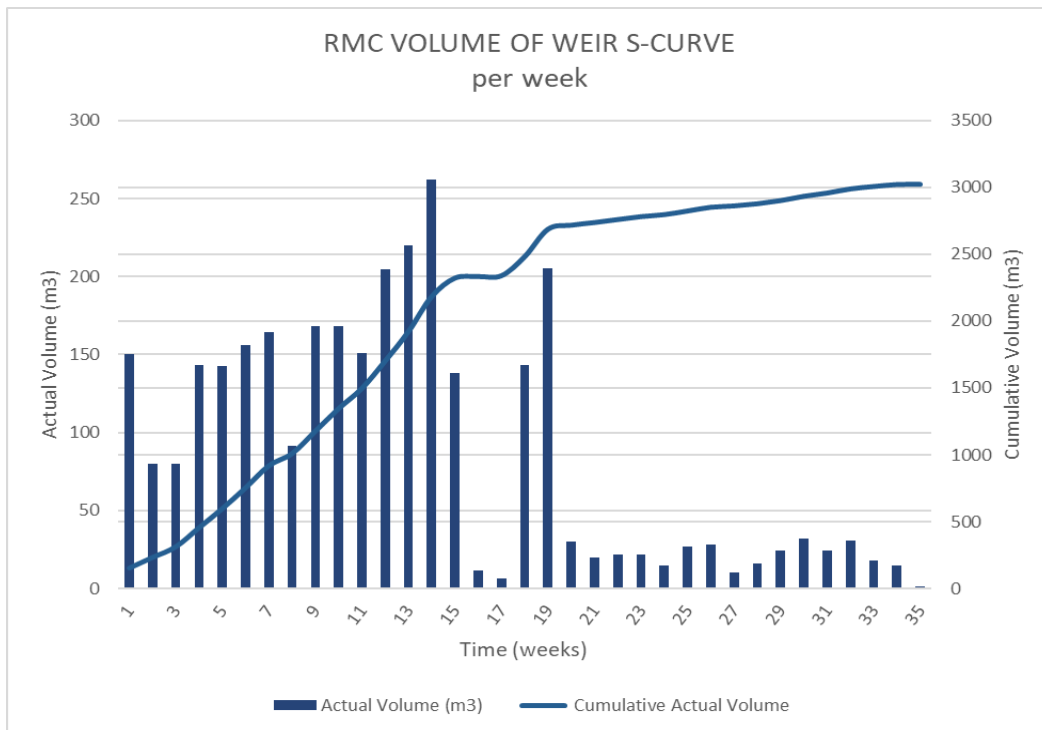
Figure 8 - RMC production S-Curve

In total the overall volume of RMC placed was 3100 m³ in the timeframe of 35 weeks. Since the RMC weir was not the only structure built under Teichmann's contract, but also the bridge over the ES approach channel, local workers were assisting with the bridge work too. This explains the fluctuation in RMC production (actual volume) as can be seen in the following chart.

It can be seen from the above S-Curve that at the beginning, with high volumes to be placed and large areas available the production was much faster than towards the end of the project when the ogee spillway crest was shaped. It can be noted that RMC production and labour decreased considerably in the second half of the period. The spillway crest construction took almost 3 times as long as the mass infills due to the time necessary for proper rock selection, neat placement and filling in accordance with the specification on the ogee section. The demand for mortar was also much lower whilst building the crest therefore the size of the batching team could be reduced. Based on the above, two RMC production rates can be distinguished:

- up to week 19 where the mass infills of the weir took place, the average RMC production was around 28 m³/day.
- from week 20-35 where the major work consisted of shaping the spillway crest, the average RMC production rate was around 6 m³/day
