Nkula A Rehabilitation Project, Malawi

Fast Track Rehabilitation

Challenges and Opportunities of Rehabilitations with Timely Limited Funding

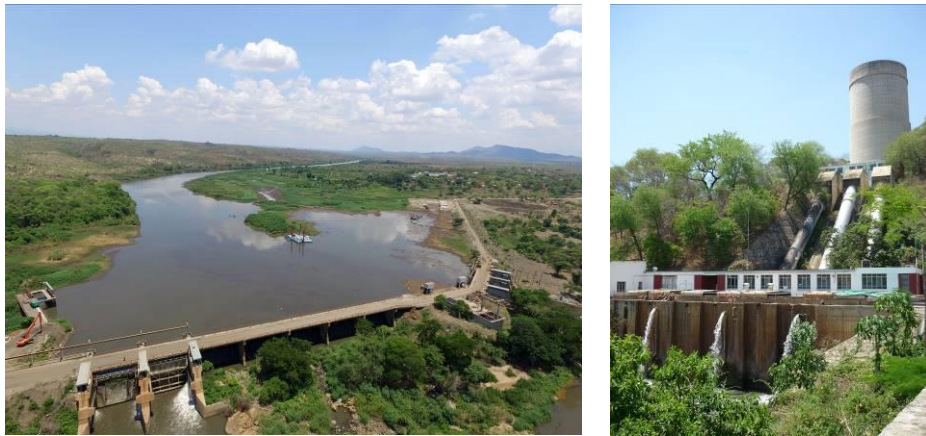
Fig. 1. Left: Nkula reservoir; Right: Nkula A hydropower station before rehabilitation

With the increasing power demand in Malawi over the years, the different stages of the Shire River cascade were constructed. As part of this development, adjacent to Nkula A, the power station Nkula B, with a capacity of 100 MW, was constructed and finally commissioned in 1996. While Nkula A was originally designed as a run-off river plant without any storage capacity, Nkula B was designed as a storage plant, including the construction a new dam, creating a head pond with a capacity of approximately 1,940,000 m³ (Fig. 1). The Nkula A intake, located next

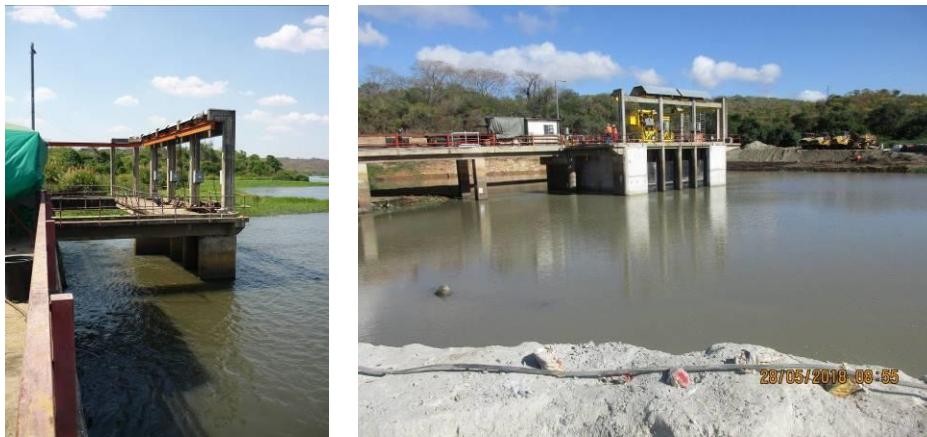
Fig. 2. Left: Nkula A intake structure before rehabilitation; Right: Nkula A intake structure after modification works

All equipment and structures for Nkula B were designed according to the new head water level at the reservoir. However, the investments on Nkula A HPP were limited to minor, incomplete modification works on the intake structure. The concept for the modifications of the intake of Nkula A did only foresee the extension of the supporting piers and the guide rails for the installation of the intake stop logs, however no lateral walls to the structure. Due to the absence of such lateral walls, extending the original intake structure, it was not possible any more to dewater the waterways of Nkula A without draining the complete reservoir, since Nkula B has been built. Inspections of the waterways or repair works at Nkula A were therefore only possible while the reservoir was empty and consequently while Nkula B was out of operation.

In addition to the rehabilitation works in the plant itself, one of the key aspects and main goals of the rehabilitation of Nkula A was the needed modification of the intake structure in such a way to allow for isolation of the Nkula A waterways without draining the reservoir and affecting the operation of Nkula B.

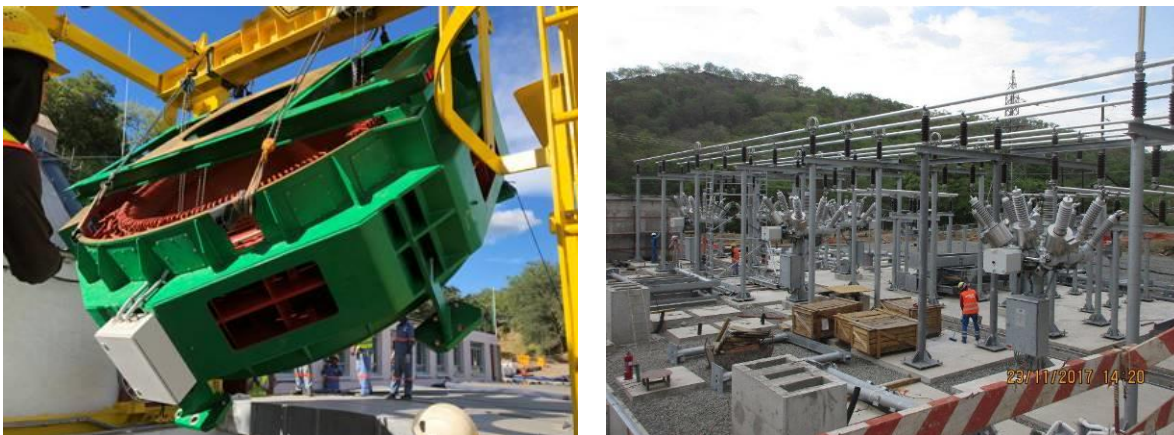
Fig. 3. Left: Lowering of the pre-assembled vacuum impregnation generator stator; Right: 66kV hybrid switchgears

Due to the age of the hydropower plant, non-availability of spare parts, overall condition as well as the possibility of considerable capacity upgrade of approximately 50%, the electrical equipment needed a total replacement. This included the replacement of all generator parts, the electrical auxiliary systems and the 66kV outdoor switchyard equipment. It was decided to install new generators with pre-assembled global vacuum impregnation stators, which only need minor assembly works at site and therefore allowed for an extremely short erection and implementation time without substantial risks. For the same reason, and the general space constraints in the switchyard area, 66kV hybrid switchgears were installed to replace the original air-insulated switchgears.

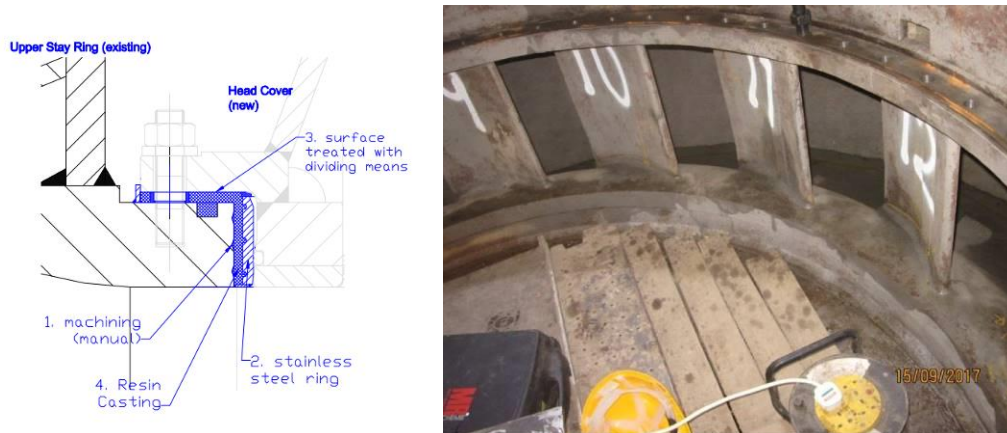
Fig. 5. Left: Sketch of modification of stay ring by insert ring and resin casting; Right: Method under implementation

As usual in rehabilitation projects, the possibility for reusing and refurbishment of existing mechanical equipment was also under discussion for Nkula A. Due to the unavailability of information about the present condition respectively doubtful condition of the existing equipment, it was however decided to replace the respective parts by new equipment. By clear definitions of the interfaces to remaining elements, the E+M contractor was in the position to deliver equipment to site for installation which was fully designed, manufactured, pre-assembled and tested in his facilities. For the three vertical Francis turbines, only the embedded parts, namely the draft tube liner, the spiral casing and the stay ring were kept for refurbishment. All other parts, incl. turbine head cover, bottom ring, turbine shaft, runner, guide bearing, draft tube cone, etc. were subject to replacement. To avoid time consuming and costly in situ machining of the stay ring for connecting the new head cover and bottom ring, it was agreed to use stainless steel

insert rings back-filled with a resin casting instead. Furthermore, since this solution does not require any material removal, it has no impact on the strength of the existing structure and does not require specific machining tools (Fig. 5). All the mechanical auxiliary systems were replaced.
